# Final Report on EA(W) Funded Project to Improve Water Body Status Within Herefordshire

## Site 1 - GB109055036620, R Arrow - conf Gladestry Bk to conf Gilwern Bk

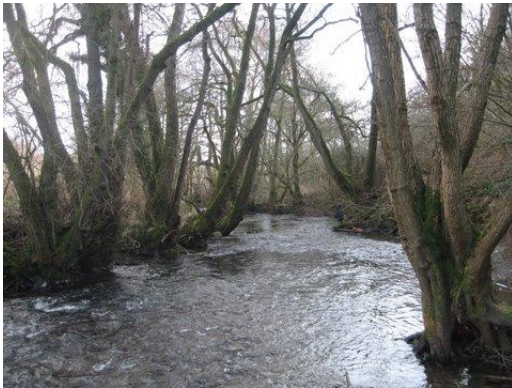
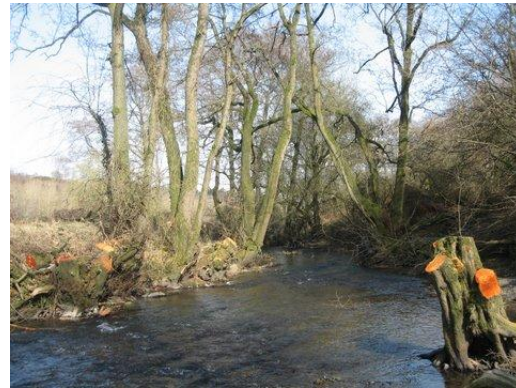
Representative photographs:

Surveys in 2006 showed this 5 km long water body to have reasonable/good riparian vegetation except for a section just upstream of Kington, which is shown in these photographs. The owners had previously been approached but work here was outside of the scope of WUF led projects to date and we welcome the opportunity provided by these funds to restore the riparian habitat in order improve the fish stocks and reduce bank sediment mobilisation at a point well upstream.

Work completed: 0.9km double bank stock exclusion and silt reduction

The site included a breeding otter holt which was in a root bowl of a leaning ash tree. Work was timed to minimise disturbance and conducted under the supervision and licence of Tom Fairfield.

The work included stabilisation of this tree to preserve the holt and during the entire period the bitch and cubs continued to use the holt.

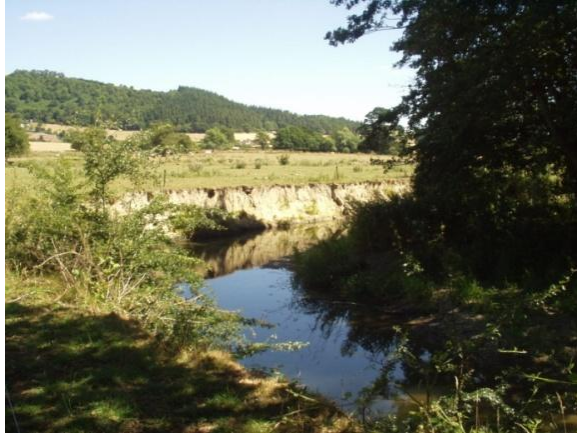
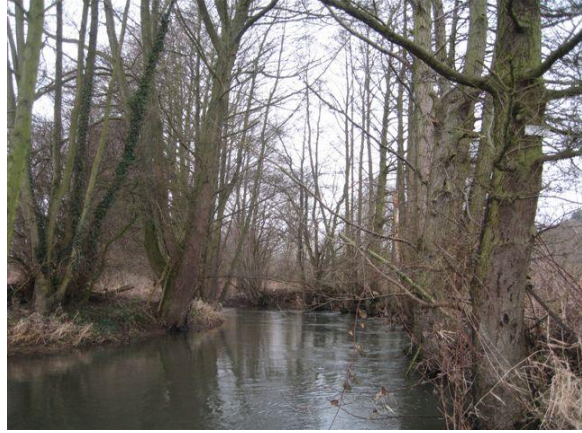
Representative before photographs:

This section, above and below the junction with the Hindwell flows through glacial tills and is susceptible to rapid lateral movements and excessive bank sediment generation which occurs when stock access to the riparian strip is un-regulated. Consented and originally targeted for work in 2007 three impacted sections were punctuated by two good quality sections that required no action.

Work: 1.6km double bank habitat restoration and silt reduction

1450m of fencing with designated drinking, 4 soft revetment and 1300m of tree management was used to stabilise the riparian corridor, reduce bank side sediment generation and improve fish habitat.

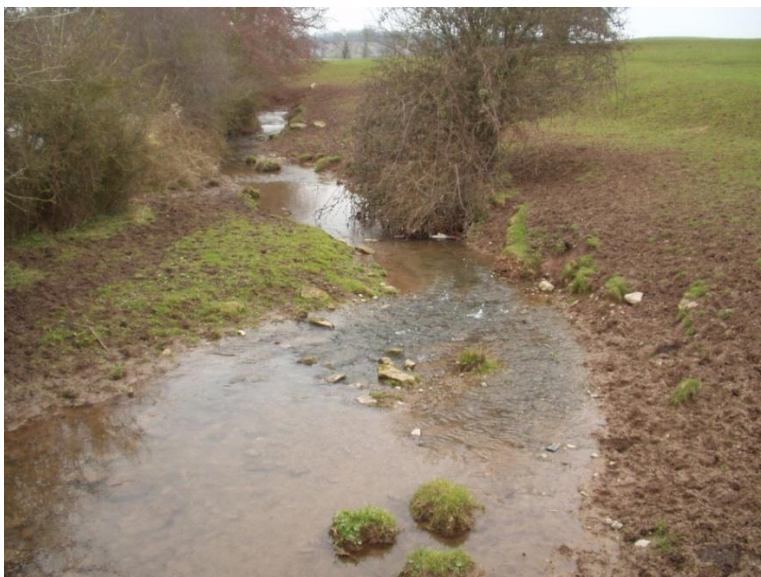
Representative before

Whilst the lower Stretford is heavily impacted by sediment from arable farming practices the upper reaches where livestock farming dominates are primarily impacted by unregulated stock access, Phosphate from a STW and livestock farming are the causes of failure. After protracted negotiations with the Lugg IDB about the merits of stock exclusion, four landowners were contacted but only one agreed to have stock excluded. Fencing materials were supplied.

Work completed: 0.8km db stock exclusion and silt reduction

It is the opinion of the foundation that there is a strong case for targeted enforcement of cross compliance in this waterbody.

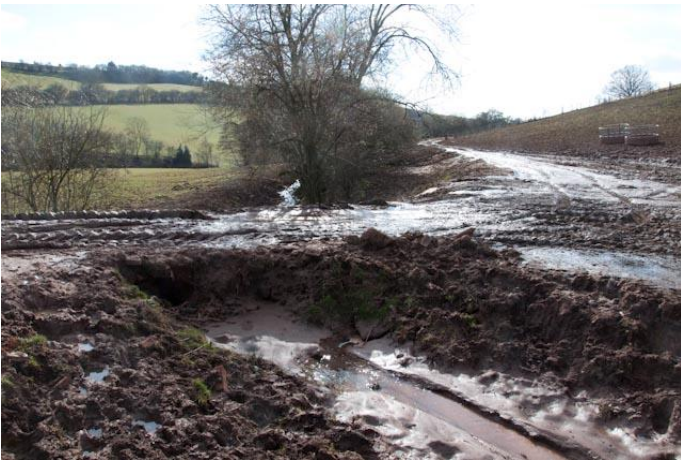
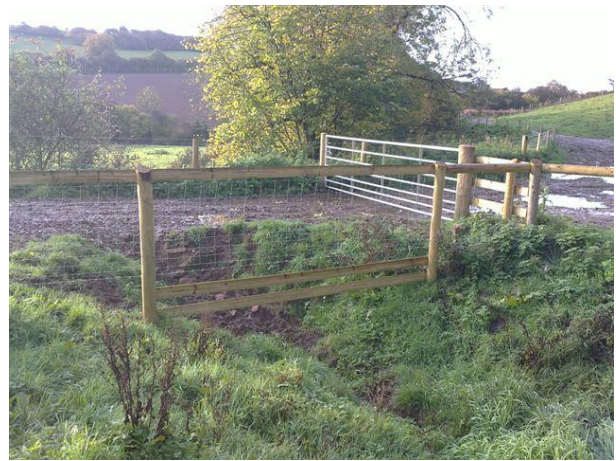
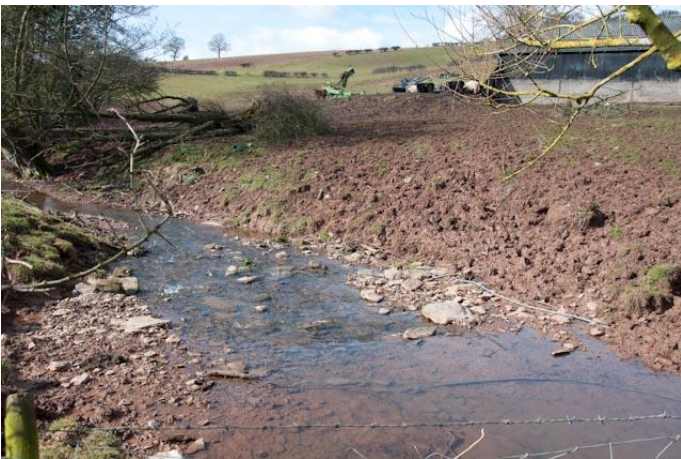
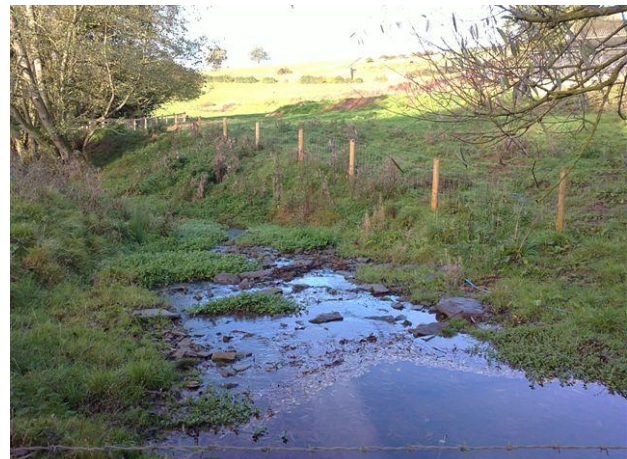
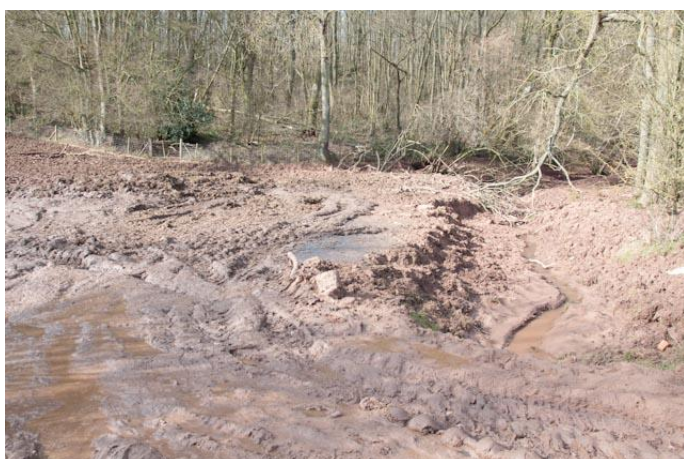
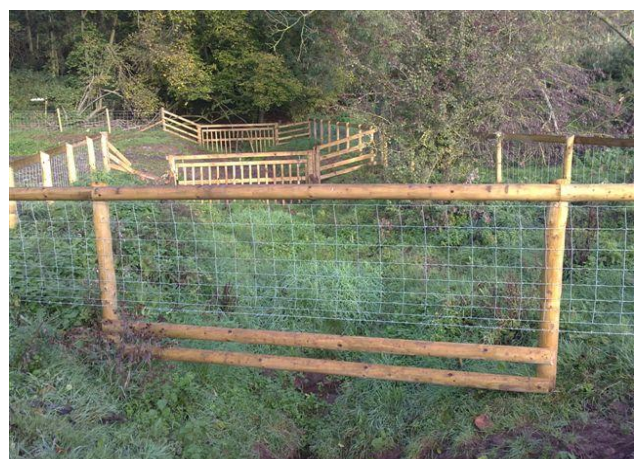
Representative photographs:

This WB is currently failing due to fish. Healthy salmonid spawning streams and reducing sediment delivery are crucial to the efforts to improve its status and we were shocked to come across this farm on potentially one of the best nursery streams in the water body.

The tree work on the lower section and the installation of the water gates was completed by WUF staff whilst the restoration of the river channel, installation of hardcore drinking place and the fencing was completed by the farmer with grant assistance, at the request of Natural England.
