Final report on Water Framework Directive spend within the Wye and Usk River Catchments, December 2008 – April 2009

Report to: Peter Gough EAW
Date: July 2009
Prepared by: Simon Evans

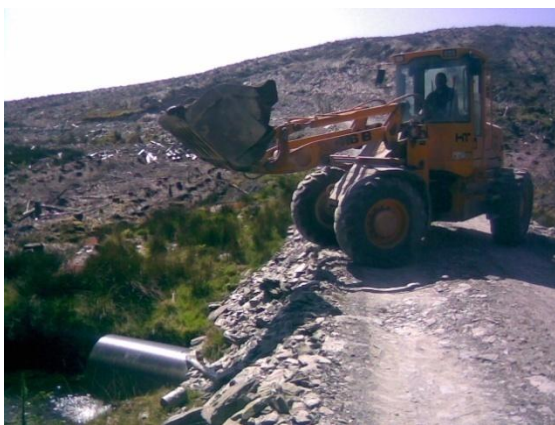
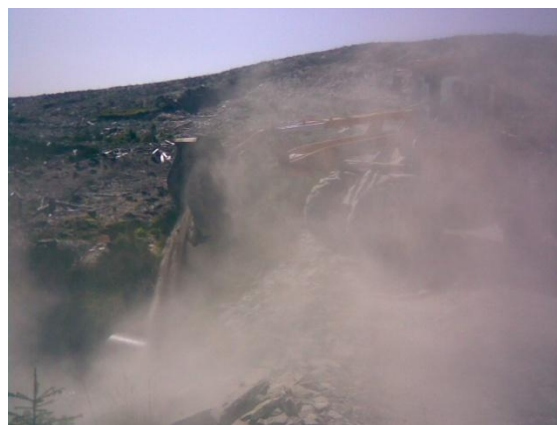
Due to heavy coniferous afforestation of the source areas, sufficient hydrological source liming is often not possible and so calcium carbonate (limestone) was introduced into 54 locations within 1st and 2nd order water courses draining into the Irfon within the Irfon and Tywi forests and the Wye within the Tarenig forest. This will act in concert with work previously conducted under the pHish (Powys Habitat Improvement Scheme ERDF Objective 2) project in 2005, 2007 and 2008 to improve 53km of river length by raising baseline pH.

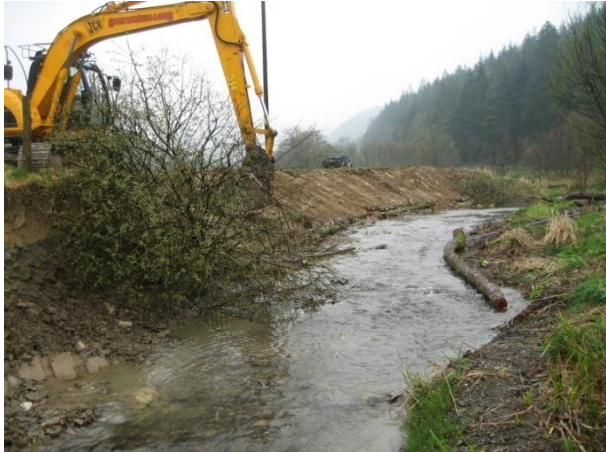
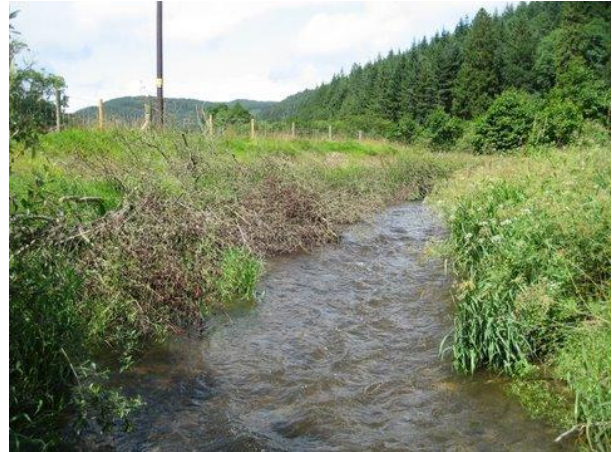
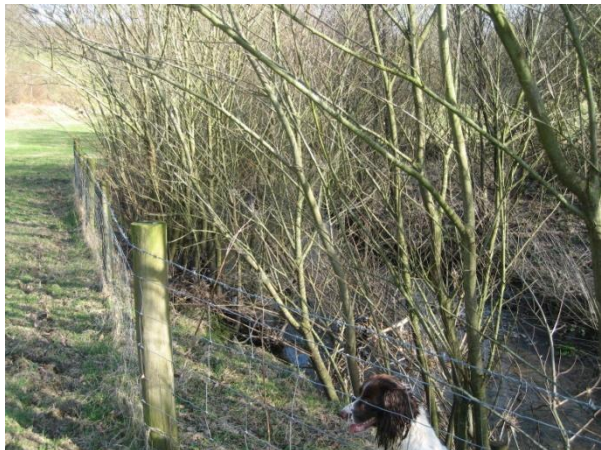
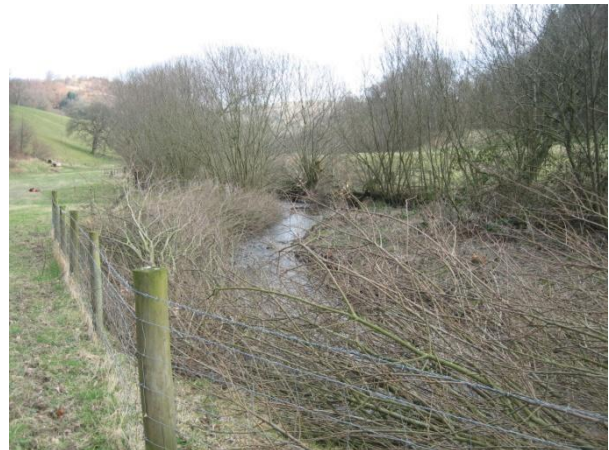
This is an important upper Wye tributary that has degraded geomorphology due to overgrazing by sheep, a history of alder coppicing and river “straightening”. It is therefore failing GES, at least partly due to the impoverished fish population.

The river was initially targeted for experimental work as part of the WHIP (Wye Habitat Improvement Project, EAGGF 5b) between 1998 and 2002. The WFD grant fund has now allowed the Foundation to complete the work started then, by coppicing remaining trees, excluding stock from the unfenced sections, pleaching in some of the woody regrowth that has occurred where stock has been excluded, all with the objective of creating ideal fish habitat. In the lower section stock were excluded by fitting 12 water-gates.

- 438m was fenced
- 2,904m was coppiced
- 260m of fence at 6 locations was repaired
- 14 Water gates, 2 gates, 2 drinking places and
- 2 soft revetments completed

This ensures favourable condition of riparian habitat within 4.31km of river

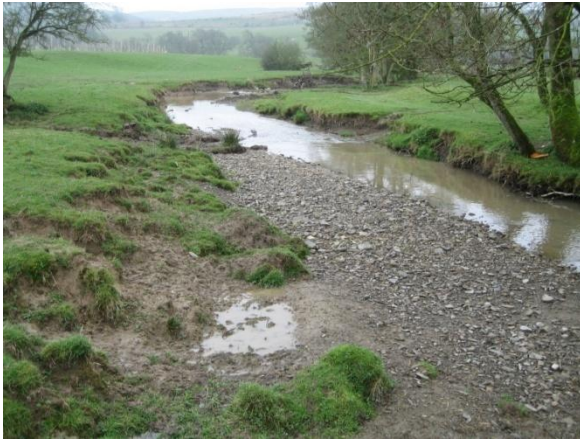
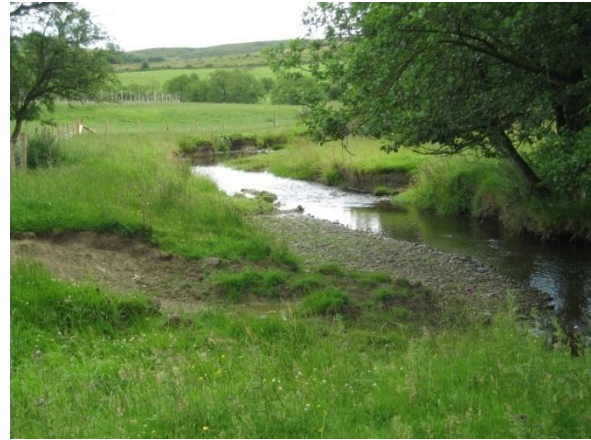
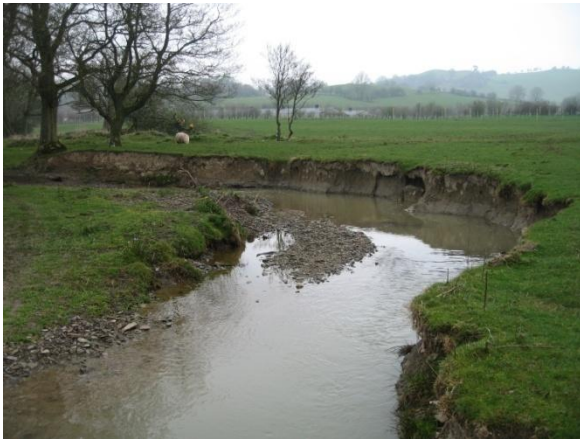
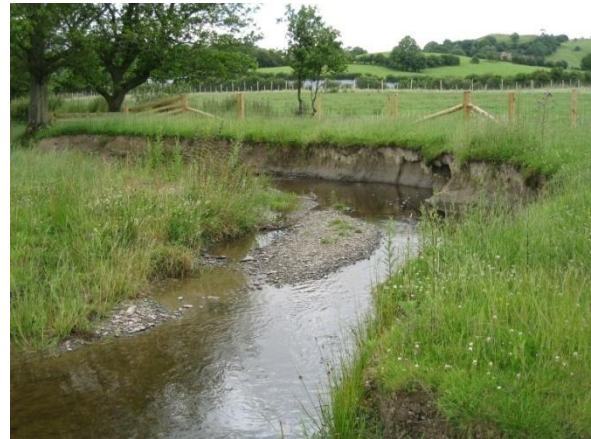
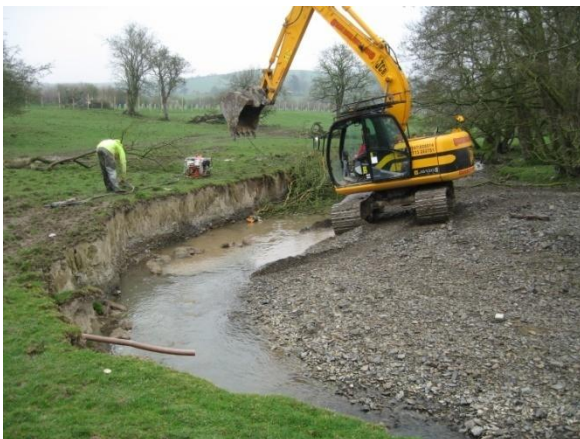
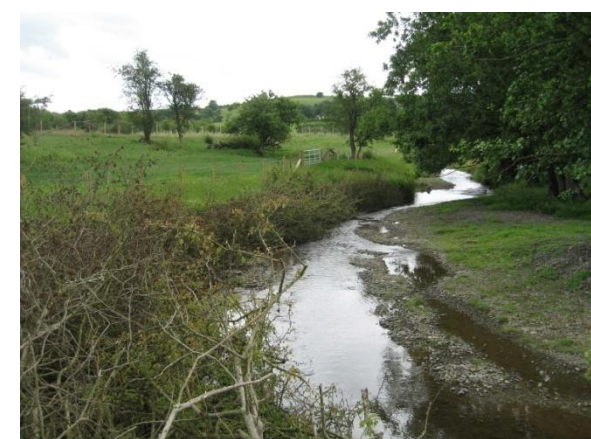
A 680m section of this stream was in a highly degraded condition due to unregulated stock access. It was identified in the survey as high risk of sheep dip entering the Camddwr, as it has been managed as a 'turn out field' adjacent to an untidy farm holding. The rest of the river is predominately in either extensive land use or fenced of via the Tir-Gofal scheme.

in what was historically, an important spring salmon spawning area. The pictures were taken 2 months apart in 2009

In total 1,200m of fencing was erected and 6 soft revetments constructed and sheep drinkers. In addition to reducing the risk of sheep dip pollution and reducing bank side sediment contributions, there will be considerable benefit to the fishery and fish population

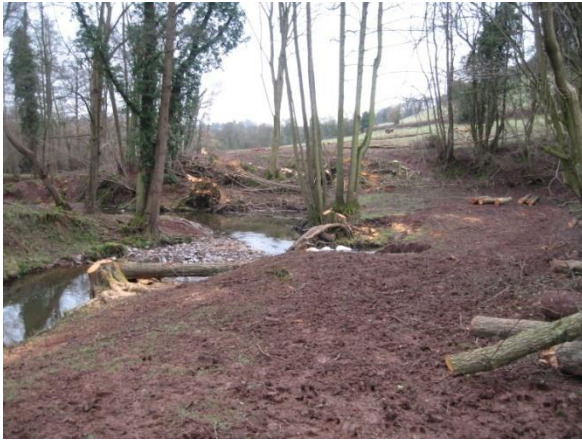
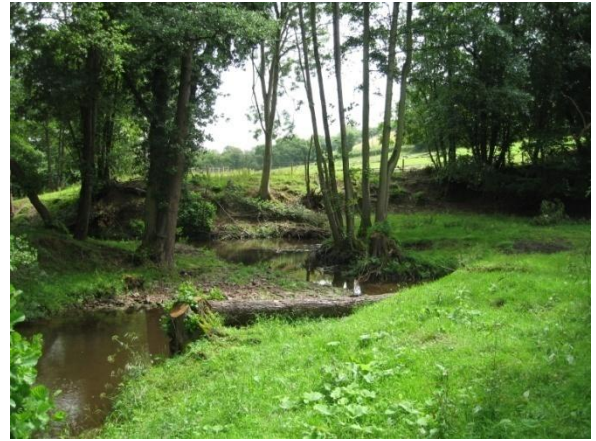
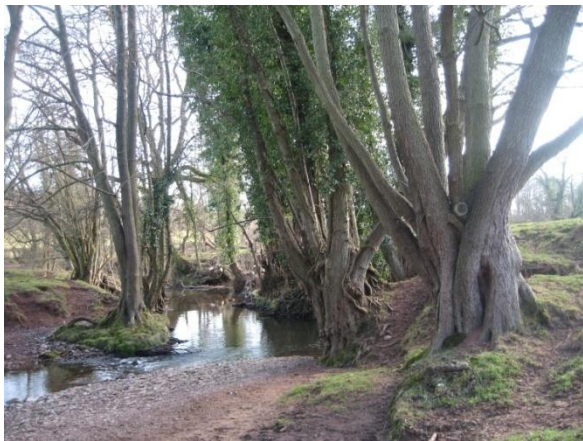
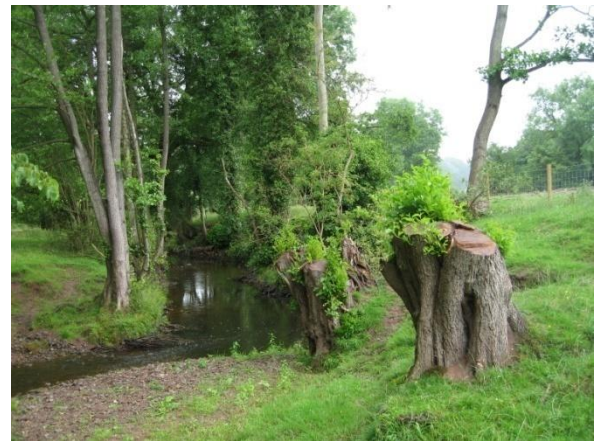
This has probably been one of the most degraded locations in the Monnow catchment. A 670m section was fenced and coppiced and this resulted in rapid improvements in the riparian zone which, it is anticipated, will improve still further as the river continues to recover.

In total 1,270m of tree management was completed, 942m of double bank fencing and 3 water gates installed to create a wide buffer to allow the river to naturalise. Inclusion of this reach in a fishery marketing scheme (The Wye and Usk Passport) will ensure that these improvements are maintained through reinvestment of some of the proceeds.

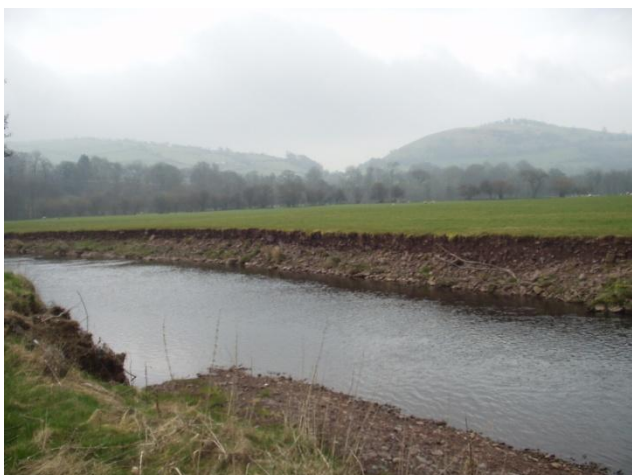
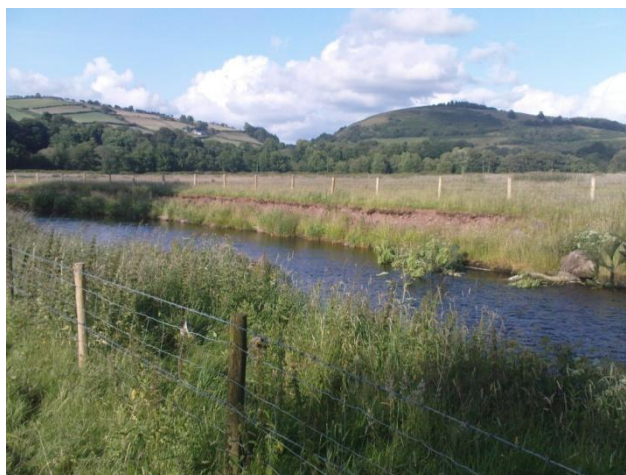
This short (4km) WB has been classified as poor due to a failure of the fish feature. Whilst this classification is debatable, it is evident that the habitat is severely degraded as exemplified by this 1090m section (before and after photos below).

In total 1,441m of double bank fencing and 4 water gates were installed to exclude stock and allow the banks to re-vegetate and the channel to narrow.

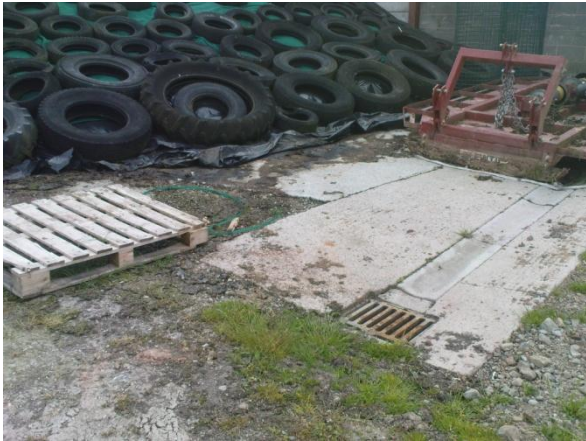
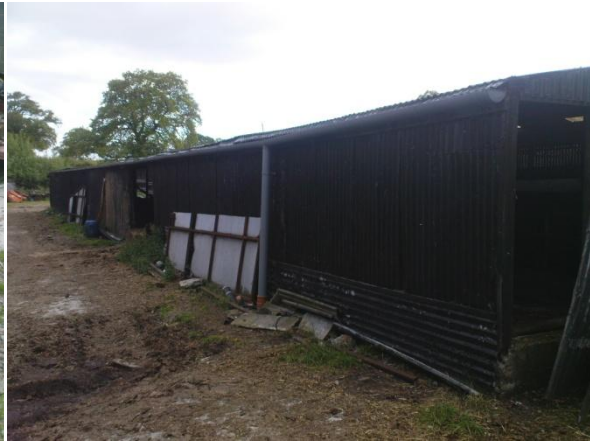
In an earlier wet weather survey of the Tippets brook this farm had been deemed to be high risk for sediment delivery. Despite the holding being over 600m from a surface water course, enriched water was observed flowing across a field and then down a road to discharge into the Tippets brook, a watercourse failing for phosphorus solely as a result of agriculture pressures.

After cold-calling the farmer, the risk was identified to be an overflowing blind ditch that acted as a catch-all for the slurry pit. The problem was exacerbated by excessive amounts of roof water flowing straight into the slurry pit as a result of a lack of guttering on a large roof area. This was resolved by making good the defective guttering. As an additional precaution, the liquor from the silage pit was separated into a catch pit.

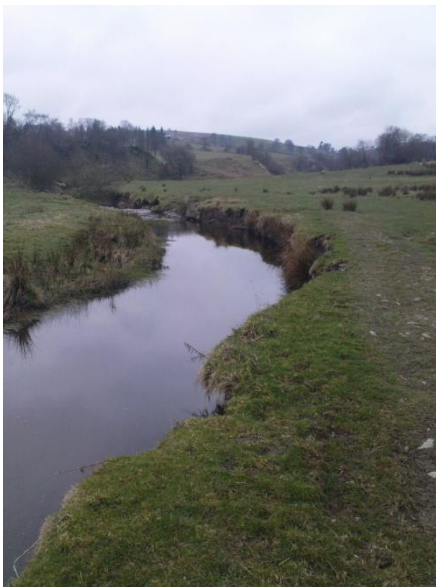
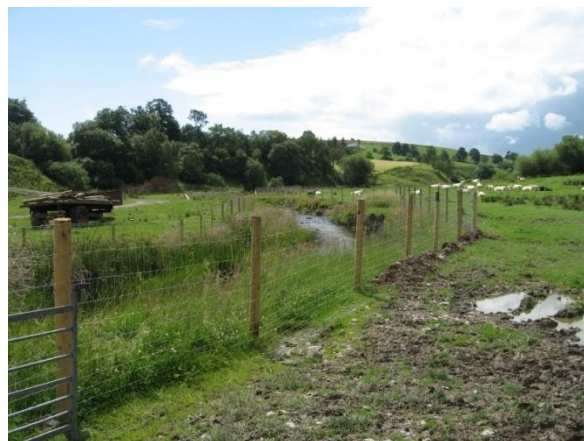
During a survey of the upper Ithon, a severely degraded section of the Llaithddu (WB 42160) failing for fish (moderate) was revealed. In this section the landowner was calving his cattle during the summer and over-wintering his sheep, as it was adjacent to the farm buildings. The result of this was a severely degraded section of river bank.

(All before and after photos taken within 3 months of each other)

Erection of 1,620m of double bank fencing in combination with 2 soft revetments and 2 water gates has protected a 1.1km section and improved the fish habitat to the point where it should not constrain future fish populations.
