Final report on National Grid Enhancement Project within the Wye and Usk catchments

Prepared by Simon Evans – Wye and Usk Foundation

September 2009

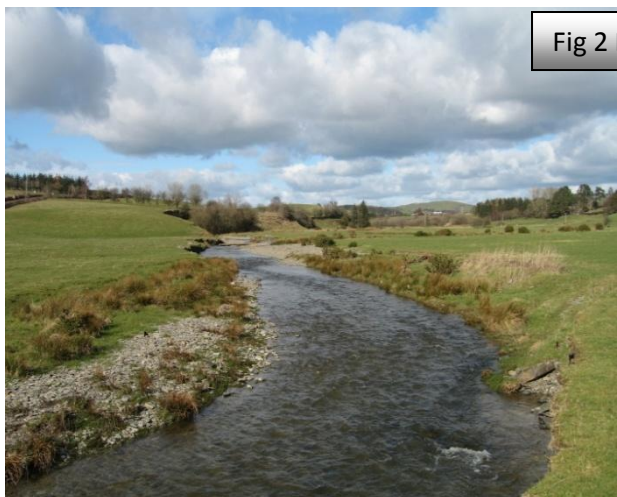
Fig 2 Pre-works condition of Afon Marteg

The Marteg is an important salmon nursery stream within the Wye catchment. A water fall in its lower reach ensures only the nationally scarce large multi sea winter fish are able to reach the middle and upper reaches. This section was one of the most degraded sections to be found in the Wye catchment. The landowner ranched high densities of yearling cattle and sheep across a 60ha unfenced unit of land through which the river flowed.

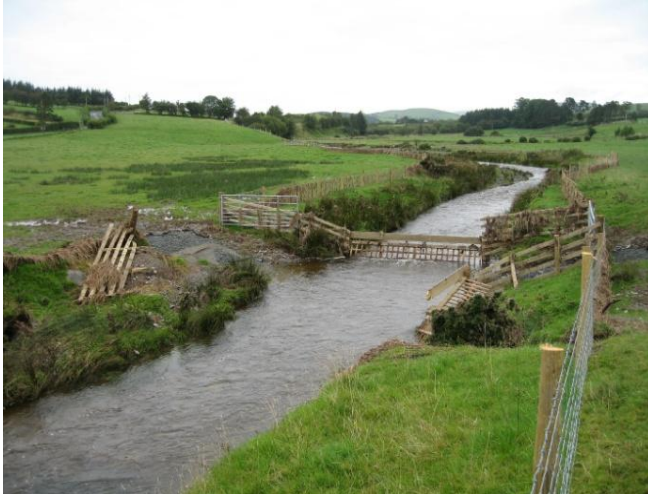
Fig 4 Post September 2008 flood

Shortly after completion of the works in August 2008 and before the banks had a chance to re-vegetate and stabilise, a 50 year return period flood came down the Marteg. This caused extensive damage to the works and additional work was required to make good the fence lines and drinking places.

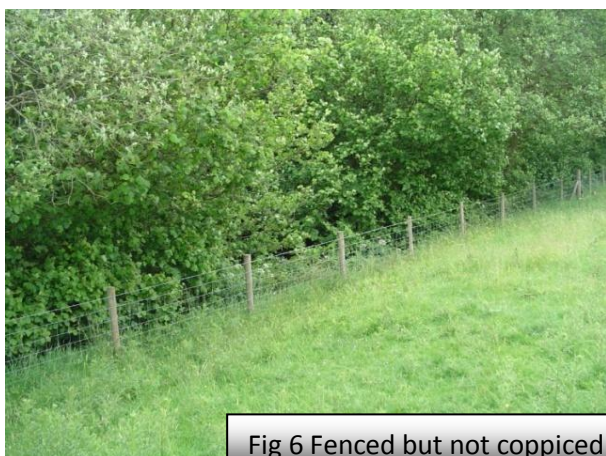
Fig 6 Fenced but not coppiced

This has left the stream only partly restored. In order to complete the works the trees need managing within these 2 sections as can be seen in the photo. The fences remain in place and in good condition meaning that with the aid of a grab. Elsewhere some minor coppicing of regrowth is required and an eroding bank requires stabilising. When combined it means a significant length of stream can be restored at relatively low cost.

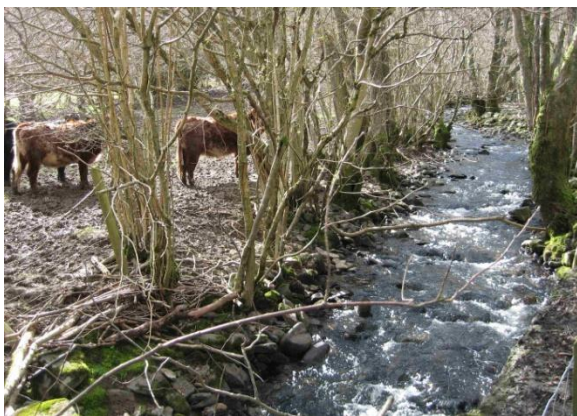
Fig 12 A representative picture of the stream prior to improvements taking place

The potential improvement was identified due to this section being severely and extensively over shaded with associated unregulated stock access. This had reduced salmon parr densities to 10-20% of estimated potential.

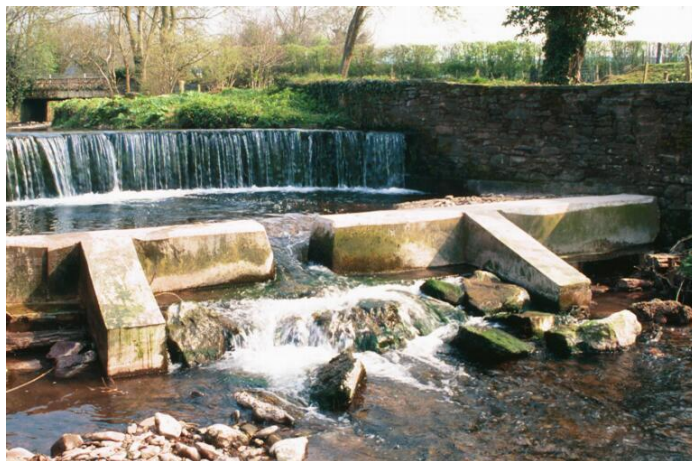
Fig 14 Prior to work

The Dgedi drains the north flank of the Black Mountains and is ideally suited to salmonids. Due to its steep gradient a series of waterfalls naturally limit fish access to the bottom 2km. Access was limited further to the lowest 350m by 2 weirs built to protect the foundations for the old railway bridge, which has since collapsed. In 2001 fish passes were constructed but subsequent electro fishing upstream has shown that access is still intermittent and the excellent habitat upstream is not being fully utilised. Further observation has determined that this is due to fish having difficulty accessing the jumping chamber of the upper pass.

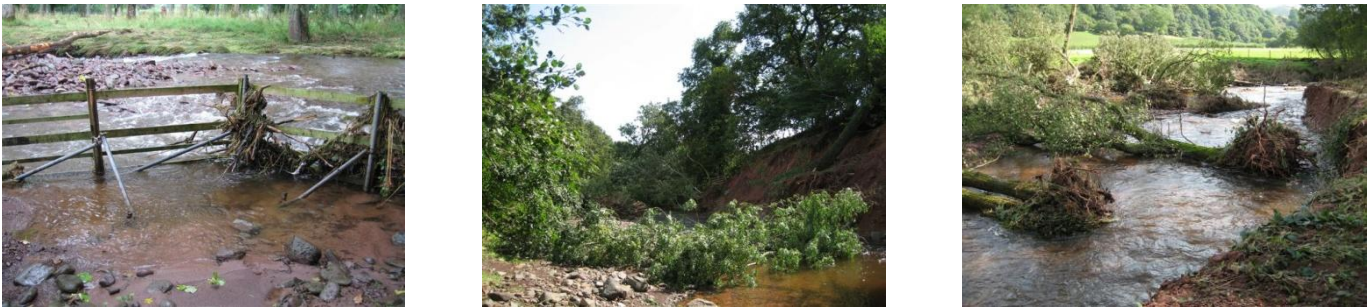
A major catchment wide flood on the 6th Sept 2008 (return period >50 years) caused extensive slope failures within the recently completed Honddu site. This introduced a large number of trees that required removing from the channel.

Figs 19-21. Immediately after the Sept 08 flood showing how the structures installed by the project had survived, but also the large amounts of woody debris introduced to the channel that required fixing/removal

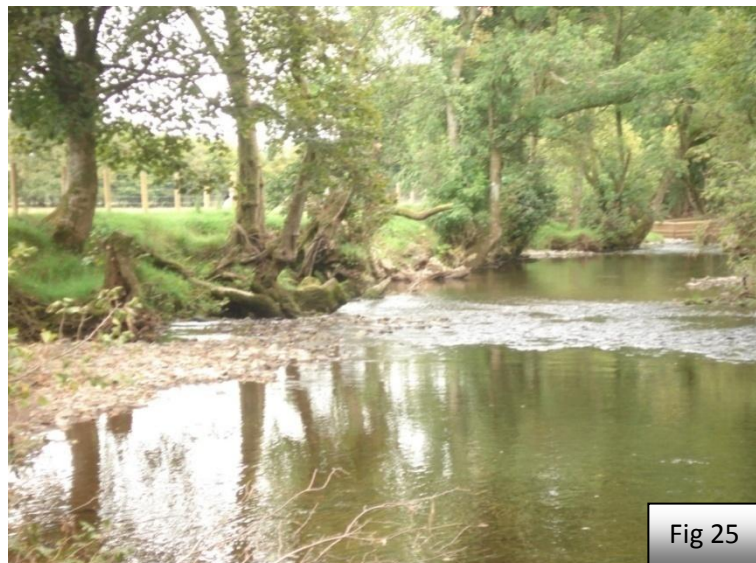
Figure 25, is a representative view of the section immediately after the work was completed.

1,145m of riverbank was selectively coppiced during the winter (2008-2009) and this summer (2009) 1,045m of fencing with 9 water gates were installed effectively restoring 853m of river. This links with the upper and lower section to create a 4km strip of excellent habitat in a key nursery area.

Shortly after completion a major flood ripped down the valley. Although all the fencing survived a large tree damaged several watergates on its way downstream. This was made good within the project.
